DEPARTMENT OF TRANSPORTATION**DIVISION OF ENGINEERING SERVICES**

Contract #: 04-0120F4Cty: SF/ALA Rte: 80 PM: 13.2/13.9File #: 69.28**WELDING INSPECTION REPORT****Resident Engineer:**Pursell, Gary**Address:** 333 Burma Road**City:** Oakland, CA 94607**Report No:** WIR-002583**Date Inspected:** 25-Apr-2008**Project Name:** SAS Superstructure**OSM Arrival Time:** 1400**Prime Contractor:** American Bridge/Fluor Enterprises, a JV**OSM Departure Time:** 2330**Contractor:** Zhenhua Port Machinery Company, Ltd (ZPMC), Changxing Island **Location:** Shanghai, China**CWI Name:** Hu Wei Qing**CWI Present:** Yes No**Inspected CWI report:** Yes No N/A**Rod Oven in Use:** Yes No N/A**Electrode to specification:** Yes No N/A**Weld Procedures Followed:** Yes No N/A**Qualified Welders:** Yes No N/A**Verified Joint Fit-up:** Yes No N/A**Approved Drawings:** Yes No N/A**Approved WPS:** Yes No N/A**Delayed / Cancelled:** Yes No N/A**Bridge No:** 34-0006**Component:** OBG/Tower**Summary of Items Observed:**

WELDING INSPECTION REPORT

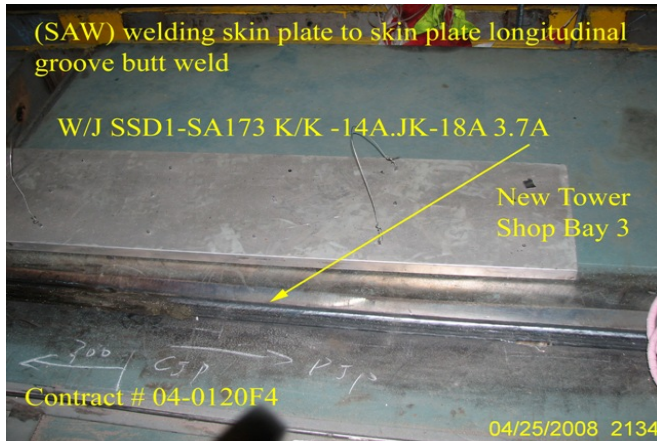
The QA Inspector randomly observed ZPMC Welding Operator Yun Chuanjin ID 0503060 utilizing the Submerged Arc Welding (SAW Process with ZPMC Weld Procedure Specifications (WPS) B-T-2321-B-P3-S and (WPS) WPS-B-T-2221-BL2-C-S-1 to weld the fill and cap passes for skin plate to skin plate weld joint identified by ZPMC as weld joint SSD1-SA173 K/K-14A JK-1.8A 3.7A.

This joint is a groove butt joint that is prepped for both a partial joint penetration (PJP) joint, and a complete joint penetration (CJP) weld. The weld transitions from 80mm thick plate on one side of the weld joint and the plate material on the other side of the weld joint is 60mm thick.

The QA Inspector visually verified a single electrode was being utilized for the filler passes and the filler metal being used was JW-3 with a diameter of 4.8 millimeters. The members are identified as P128+P126 SA173, and the material grade is identified as 345+345.

The work being performed was in progress generally appeared to conform to contract specifications. For more detail see photographs shown below:
